TECHNICAL BULLETIN

Publication No. 14560036 3/10

RCCR RECEIVER SQUELCH BLOCKING

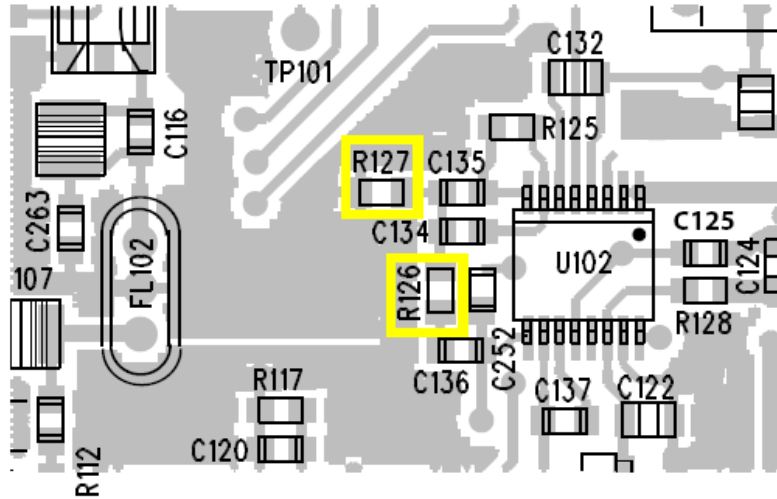
RF BOARD COMPONENT PLACEMENT

- Models affected:** All RCCR Locomotive units shipped before 2/25/2010.
- Symptom:** Some customers experienced intermittent squelching of the receivers even under strong RF levels.

- Cause:** Certain voices with high frequency audio content could appear as noise to the squelch circuit.
- Solution:** If you are experiencing this condition with a warranty radio, and you are unable to make the modifications without damage to the PC board and complete the realignment, return the radio freight prepaid to Ritron, and we will modify it at no charge.
NOTE: You must have the proper tools and experience to work with Surface Mount Technology components.

- Modifications:** On the 9/RCCR-RF board, under the top cover, change R127 from a 1.5k Ω 0603 resistor to a 1.0k Ω 0603 resistor. This change increases the center frequency of the squelch noise filter from 3.6 kHz to 4.4 kHz so that voice audio does not affect the level of squelch noise.

Change R126 from a 180 k Ω 0603 resistor to a 220 k Ω 0603 resistor. This change will increase the dynamic range of the noise squelch at 12 dB SINAD levels.
- Notes:** After the modifications are completed, all squelch settings should be re-adjusted, using the Align Section of the RCCR PC Programmer.
