Ritron, Inc.

Publication No. 14670037 Rev A

Loudmouth - Occasional No Audio Output

LM-600Analog, LM-700DMR, LM-U450, LM-V150

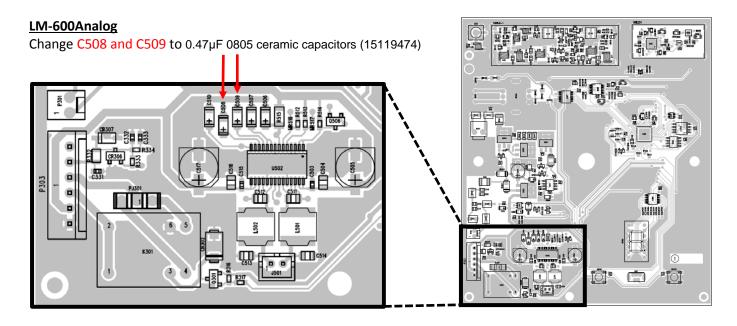
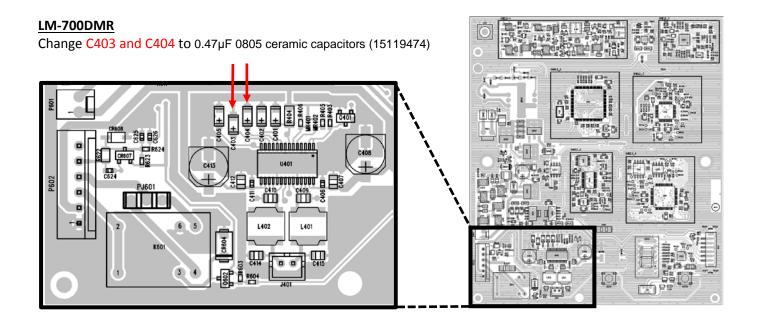
The problem is due to reverse voltage on the audio PA tantalum input capacitors when the radio is in standby mode. When the radio goes to receive mode the voltage reverse on the capacitor causes an input voltage offset on the audio PA that triggers an internal shutdown. This appears to be a condition that is more likely to occur over time.

Change audio PA input capacitors from 1µF tantalum capacitors (152A8105) to 0.47µF 0805 ceramic capacitors (15119474)
